SOUTHWEST ELEVATION/SECTION
N.T.S.

*Plan of
Orient Point
Lighthouse*

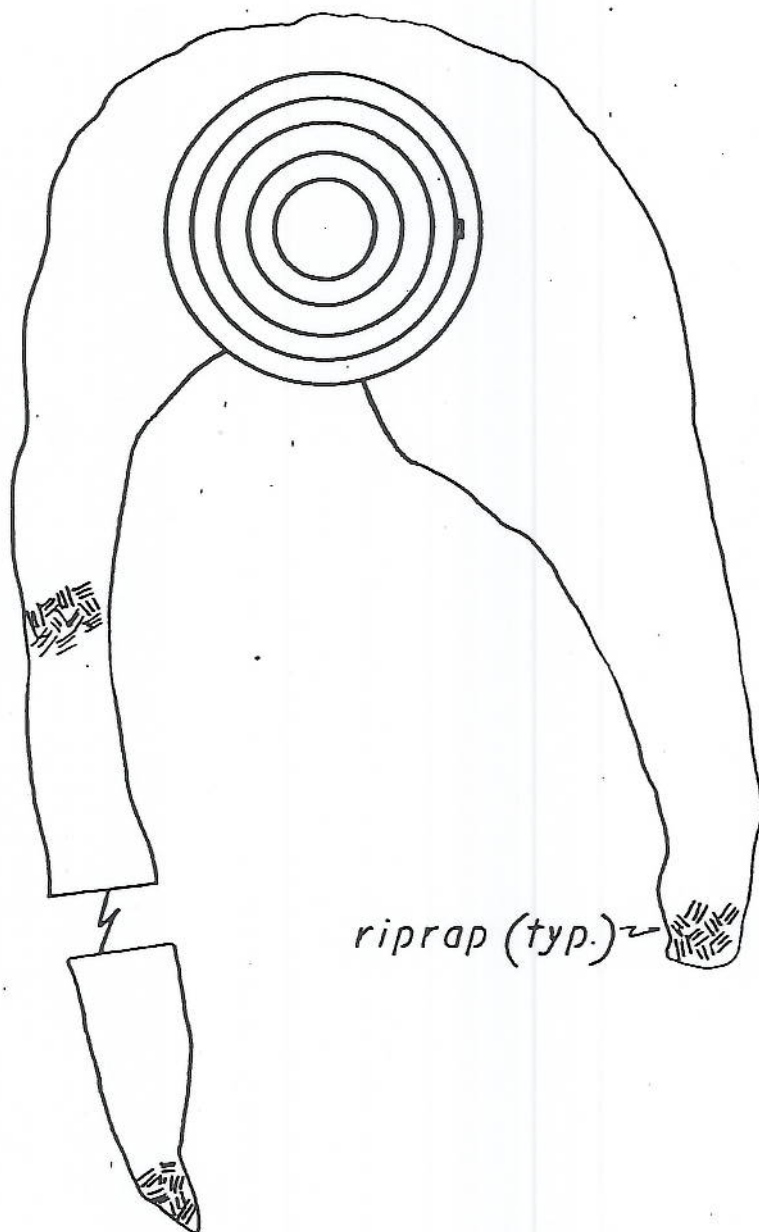
1. No mooring or boarding facilities are provided in the basin. Large endanger craft and threaten the safety of Coast Guard personnel.
2. Access ladder to gallery attached to perimeter of deck; therefore th access by unauthorized individuals.

3. Abandoned pipe, submarine cables and conduits penetrate the caisson cables chased through bulkheaded porthole at east quadrant. Some abandone and plugged.

4. Horizontal and vertical cracking and disbonding of thick, brick mase ice jacking as a result of seawater entering voids at the gallery level.
5. Cylindrical cast iron caisson bearing on rock and ballasted with cor structure. Several large diagonal cracks and partial repair plate observ splits at caisson flanges near top, especially at northern quadrants, ap

6. Radial cracking of cast iron exterior deck plates at gallery as a r associated with outward movement of upper portion of caisson.
7. Superstructure bears on thick, brick masonry walls which line the c. caisson and superstructure plating and masonry below filled by cast-in-p crack occurs along the face of the superstructure permitting water to en

8. Exterior cast iron wall lined with brick masonry laid up in common l
9. Original cast iron, curved roof beams replaced with structural shap Asbestos lumber presently comprises the roof decking.

10. Windows bulkheaded with 3/4" plywood fitted with hooded ventilators bolts and 2x4 strong backs.
11. Stairway bulkheading and fourth floor decking are corroded and dete structure from the watch level above.

13. Upper portions of structure serve as roost for cormorants. Exterio fouled with excrement..
14. Top railing and several decorative finials missing from rail assemb

17. Several bronze retaining strips which secure lantern lites are missi deteriorated.
18. Original lantern removed and replaced with contemporary model.
